AIRCRAFT LOG
AF5-1

MANUFACTURER Cirrus Design Corporation MODEL SR22 DATE OF MFG. 02/2003
SERIAL NUMBER 0465 REGISTRATION NUMBER N516CD

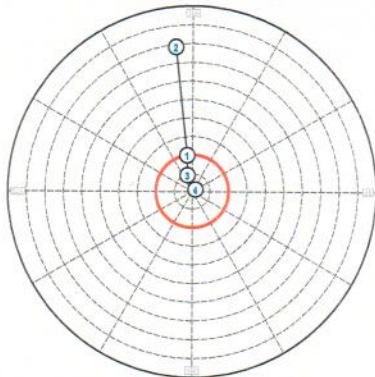
— POLAR PLOT - 1.0 IN/S FS —

ENGINE/PROP DYNAMICALLY BALANCED

Performed a dynamic propeller balance IAW FAA APPROVED Chadwick Helmuth doc AW 9511-2 dated 12 June 1990 using DSS Microvib II equipment and application note AN-MV2 Prop Rev 00 1 July 2003. Initial IPS of .199 @ 2553 rpm reduced to .023 IPS @ 2551 rpm by installation of AN hardware balance weights on spinner rear bulkhead. Jim Barker A&P 2755069 Aviation Resources, LLC 101 Airport ave Hangar 7 Cumberland, WI 54829 Hangar (715) 822 5787 Cell (715) 491 1303 Jim@aviationvibes.com www.aviationvibes.com
