Airframe Index
N172RV S/N 172S10116

Airframe Items

Engine Index
N172RV S/N 172S10116

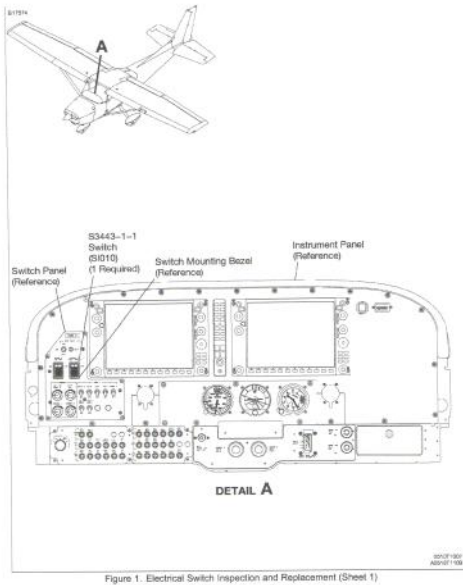
Figure 1. Electrical Switch Inspection and Replacement (Sheet 1)

An inspection of the airplane paperwork is accomplished to determine the length of time the installed AVIONICS switch has been in service. Switches that have been in service for 500 hours of operation or more shall be replaced.

- A one time inspection of the maintenance records of the airplane to determine the time in service of the AVIONICS switch shall be accomplished at the next 100-hour / 12-month (annual-type) inspection.
- The part number S3443-1-1 AVIONICS switch shall be replaced every 500 hours of operation.
- Subsequent actions: This Service Bulletin and 500-hour component life limit shall remain in effect until superseded by revision of the Component Time Limits Section of the airplane Maintenance Manual (latest revision).

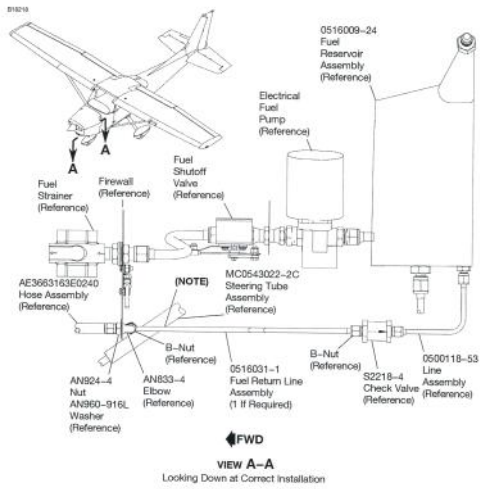
Figure 1. Fuel Return Line Inspection (Sheet 1)

A report has been received that a part number 0516031-1 Fuel Return Line Assembly was found rubbing against the right steering tube assembly during rudder pedal actuation.

NOTE: Turn the nosewheel with a tow bar and move the cockpit's rudder pedals at the same time while you look at the MC0543022-2C Steering Tube Assembly as it moves through its full range of motion to make sure it does not touch the 0516001-1 Fuel Return Line Assembly or the airplane structure.

- (2) If there is no damage to the 0516031-1 Fuel Return Line Assembly, but it does touch the MC0543022-2C Steering Tube Assembly when the rudder pedals and nose wheel travel
