AIRCRAFT TECHNICAL LOGS

AIRFRAME LOG

1. Nationality and Registration N569CA
2. Manufacturer's Designation DA 40
3. Record of
 - (a) Engine Installations
 - (b) Propeller Installations
 - (c) Airworthiness Directives (A/D)
 - (d) Service Bulletins (S/B)
 - (e) Special Inspections (S/I)
 - (f) Modifications (MODS)

MAJOR REPAIR AND ALTERATION (Airframe, Powerplant, Propeller, or Appliance)

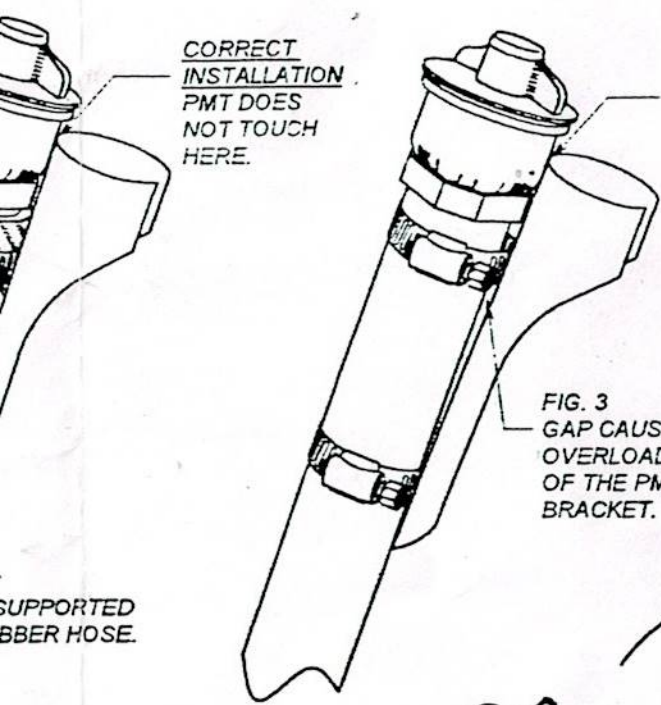
IMPROPER
INSTALLATION OF PMT.
BRACKET IS HITTING
FILLER TUBE.

FIG. 3
GAP CAUSES
OVERLOADING
OF THE PMT
BRACKET.

FIG. 3 IS AN EXAMPLE OF IMPROPER INSTALLATION OF THE PMT BRACKET. THIS WILL CAUSE OVERLOADING OF THE THE BRACKET.

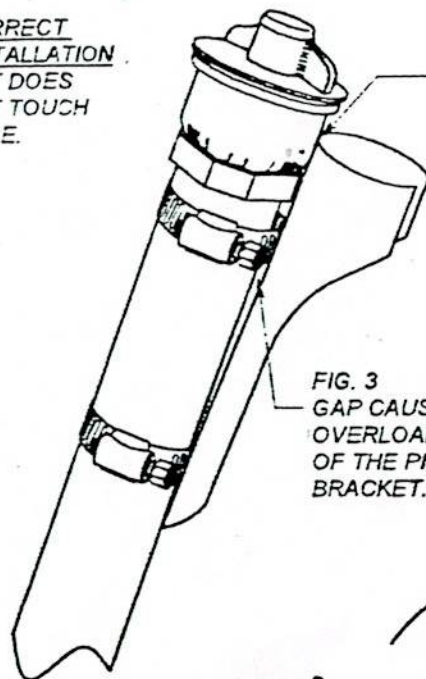
FIG. 3
GAP CAUSES
OVERLOADING
OF THE PMT
BRACKET.
