AIRCRAFT
MAINTENANCE
RECORDKEEPING
SYSTEM

N611BJ

**AVIONICS
MAINTENANCE
RECORDS**

Aircraft Registration No. N611RJ
Aircraft Manufacturer The Lancoir Co.
Model LC4-550 FL
Serial No. 41044

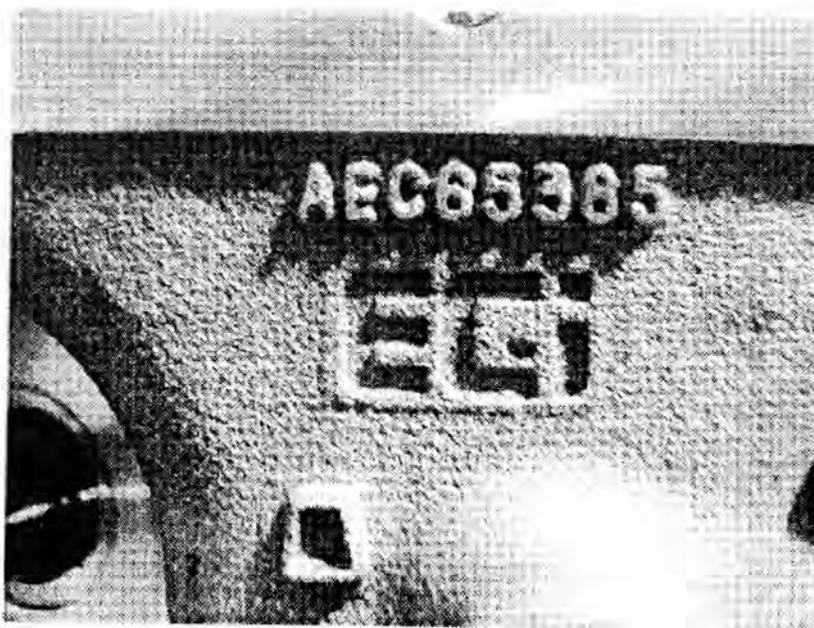
Figure 3. ↑

(iii) If the casting has AEC65385, and an "O" under the ECi logo, the cylinder is P/N AEC631397. See Figure 3.

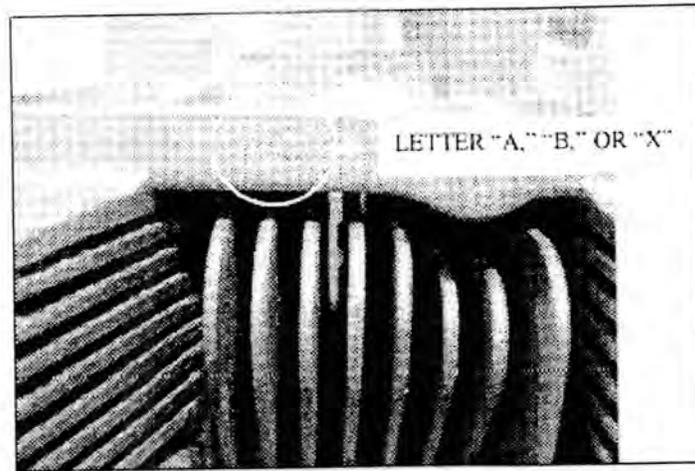
Figure 4. ↑

(ii) If there is a letter "A," "B," or "X" stamped on the flange of the rocker box, no further action is required. See Figure 4

(iii) If there is no letter "A," "B," or "X" stamped on the flange of the rocker box, replace the cylinder before further flight.
