INSPECTION SUPPLEMENT AND WORK ORDER

WKO#: 1023419
Mech: SJR
Shop Code: F
Equip Code: A
Opened: 10/23/2002 10:05

N#: N777ND AofType: SR20

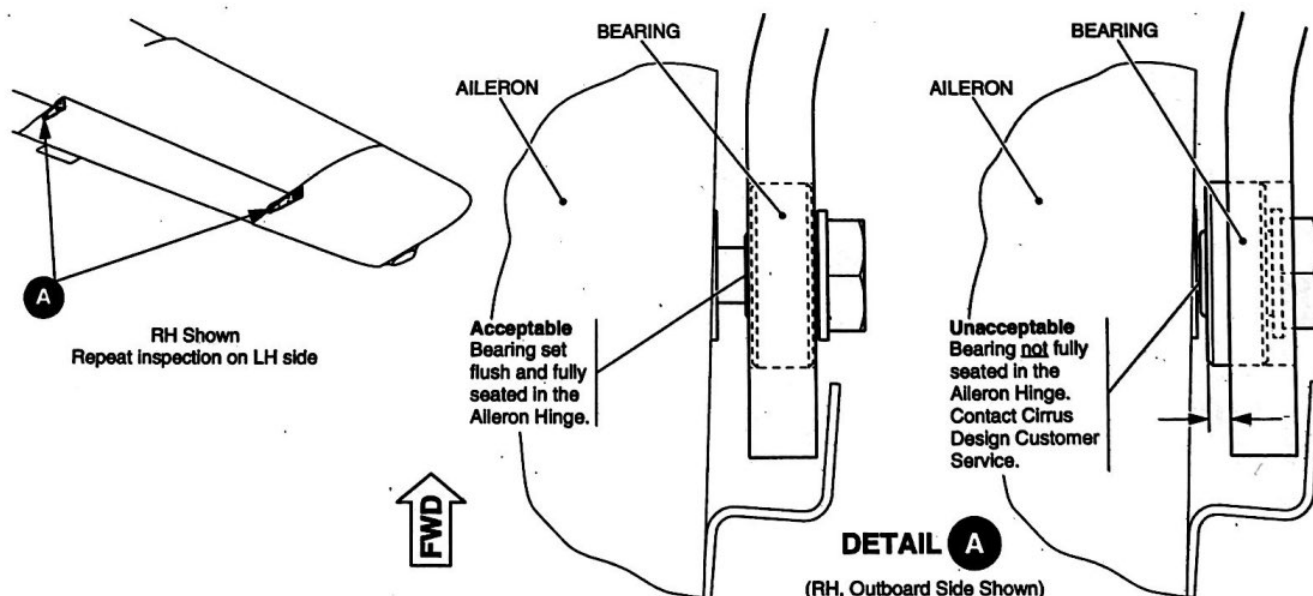
SA 04-09
1 of 1

Cirrus operators must visually inspect the aileron hinge bearings to assure that the bearings are fully seated in the aileron hinge. A properly seated bearing is indicated when the bearing face is flush with the aileron hinge surface. The illustration below depicts both acceptable and unacceptable installations. If a bearing is found to protrude from the aileron hinge surface, call Cirrus Design Customer Service (1-800-279-4322) for disposition. This visual inspection must be accomplished before every flight until the Service Bulletin is accomplished.

A Mandatory Service Bulletin is under development which will correct this condition. Additionally, Cirrus Design expects that the FAA will issue an Airworthiness Directive to require compliance with this Service Bulletin.
