Propeller Logbook

1. Manufacturer Mc Cauley

2. Type/Model/Series D3A34C443/¹⁶#78CYA-0

3. Serial Number 023167

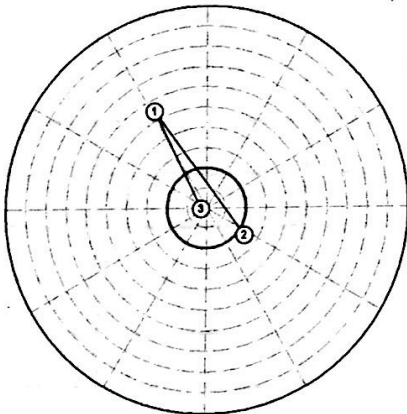
ENG/PROP DYNAMICALLY BALANCED

Performed a dynamic propeller balance IAW FAA APPROVED Chadwick Helmuth doc AW 9511-2 dated 12 June 1990 using DSS Microvib II equipment and application note AN-MV2 Prop Rev 00 1 July 2003. Initial IPS of .548 @ 2581 rpm reduced to .028 IPS @ 2574 rpm by installation of AN hardware balance weights on spinner rear bulkhead. Jim Barker A&P 2755069 Aviation Resources, LLC 101 Airport ave Hangar 7 Cumberland, WI 54829 Hangar (715) 822 5787 Cell (715) 491 1303 Jim@aviationvibes.com www.aviationvibes.com

Front
MicroVib II SN:1177 Cal:01/16/2014
Initial: 0.647 IN/S @ 2580.9 RPM Final: 0.029 IN/S @ 2574.4 RPM
