Engine Log
 N96SB
 04-24-2013

ENGINE MODEL: IO-550-N (7) ENGINE S/N: 1007887 REG. NO: N96SB WORK ORDER: 5501-06-2013

Engine Repair Record

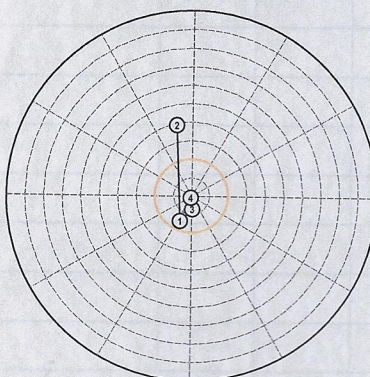
ENG/PROP DYNAMICALLY BALANCED

Performed a dynamic propeller balance IAW FAA APPROVED Hartzell Service Instruction #145 and Chadwick Helmuth doc AW 9511-2 dated 12 June 1990 using DSS Microvib II equipment and application note AN-MV2 Prop Rev 00 1 July 2003. Initial IPS of .150 @ 2560 rpm reduced to .012 IPS @ 2553 rpm by installation of AN hardware balance weights on spinner rear bulkhead. Jim Barker A&P 2755069 Aviation Resources, LLC 101 Airport ave Hangar 7 Cumberland, WI 54829 Hangar (715) 822 5787 Cell (715) 491 1303 Jim@aviationvibes.com www.aviationvibes.com
