ENGINE LOG BOOK

Engine Service and Maintenance Record

<p>AVIATION RESOURCES 101 Airport Ave, Hangar 7 Cumberland, WI 54829</p>	N96SB					ENGINE LOG BOOK ENTRY		2/17/20
	Cirrus	SR22	S/N 0465	Flight		Hobbs	2244.5	
	Continental	IO-550-N (43)	S/N 1038431	Flight		TTE	0.0	
	Hartzell	PHC-J3YF-1RF	S/N FP8268B	Flight		TSOH	825.0

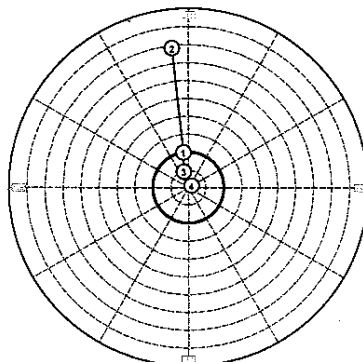
— POLAR PLOT - 1.0 IN/S FS —

Performed a dynamic propeller balance IAW FAA APPROVED Chadwick Helmuth doc AV 9511-2 dated 12 June 1990 using DSS MicroVib II equipment and application note AN-MV2 Prop Rev 00 1 July 2003. Initial IPS of .199 @ 2553 rpm reduced to .023 IPS @ 2551 rpm by installation of AN hardware balance weights on spinner rear bulkhead. Jim Barker A&P 2755069 Aviation Resources, LLC 101 Airport ave Hangar 7 Cumberland, WI 54829 Hangar (715) 822-5787 Cell (715) 491-1303 jim@aviationvibes.com www.aviationvibes.com

N96SB Cirrus SR 22 465 2258.1 Hrs
IO 550 N 43 1038431
Front of engine
MicroVib II SN:1177 Cal:03/30/2020
Initial: 0.199 IN/S @ 2552.5 RPM Final: 0.023 IN/S @ 2551.1 RPM
