AIRCRAFT TECHNICAL LOGS

AIRFRAME LOG

1. Nationality and Registration N569CA
2. Manufacturer's Designation DA 40
3. Record of
 - (a) Engine Installations
 - (b) Propeller Installations
 - (c) Airworthiness Directives (A/D)
 - (d) Service Bulletins (S/B)
 - (e) Special Inspections (S/I)
 - (f) Modifications (MODS)

MAJOR REPAIR AND ALTERATION (Airframe, Powerplant, Propeller, or Appliance)

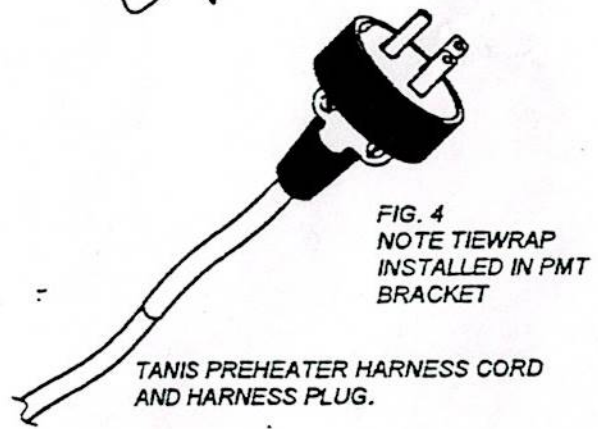
FIG. 4
NOTE TIEWRAP
INSTALLED IN PMT
BRACKET

INSTALL THE HARNESS PLUG IN THE PMT AS SHOWN IN FIG. 4.

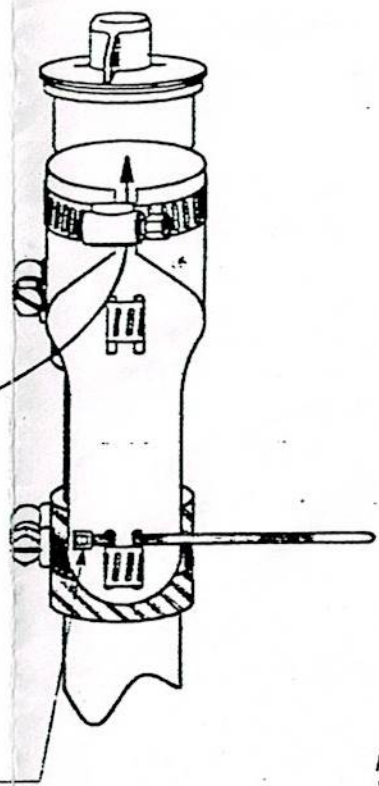
FIG. 5
HARNESS PLUG
INSTALLED IN PMT
SECURED WITH WORM
CLAMP AND TIEWRAP.
BE SURE PLUG IS
ACCESSIBLE THROUGH
OIL DOOR.

SECURE THE PLUG IN THE PMT BRACKET USING THE LARGE WORM CLAMP, SECURE THE CORD USING A TIEWRAP AS SHOWN IN FIG. 5.

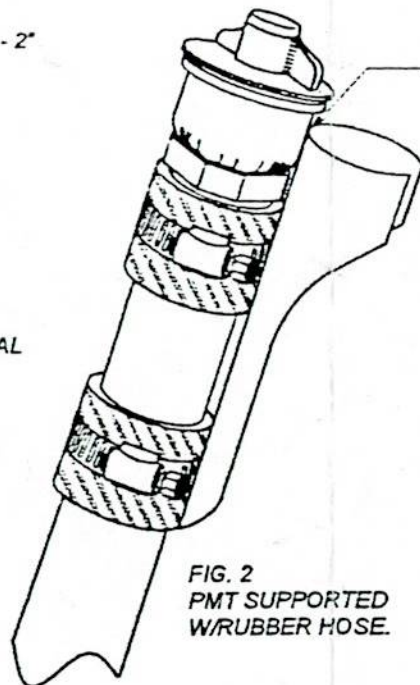
FIG. 2
PMT SUPPORTED
W/RUBBER HOSE.

INSTALL THE RUBBER TUBING ON THE OIL FILLER TUBE AND SECURE THE PMT BRACKET IN PLACE USING THE 2 SMALLER WORM CLAMPS AS SHOWN IN FIG. 2. POSITION THE PMT SO THAT IT IS ACCESSIBLE THROUGH THE OIL FILLER DOOR. THE BRACKET SHOULD NOT CONTACT THE FILLER TUBE AT THE TOP END. DO NOT OVER TIGHTEN THE WORM CLAMPS.

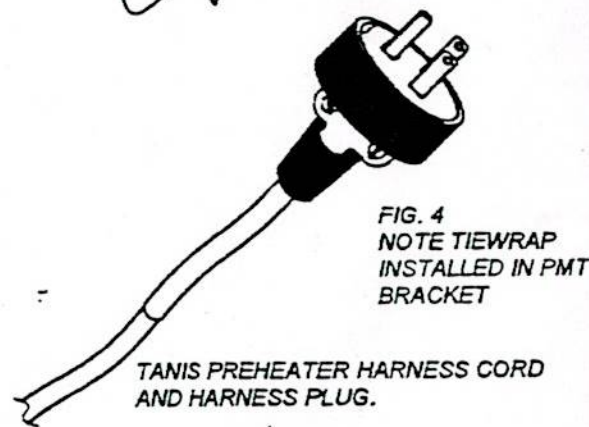
FIG. 4
NOTE TIEWRAP
INSTALLED IN PMT
BRACKET

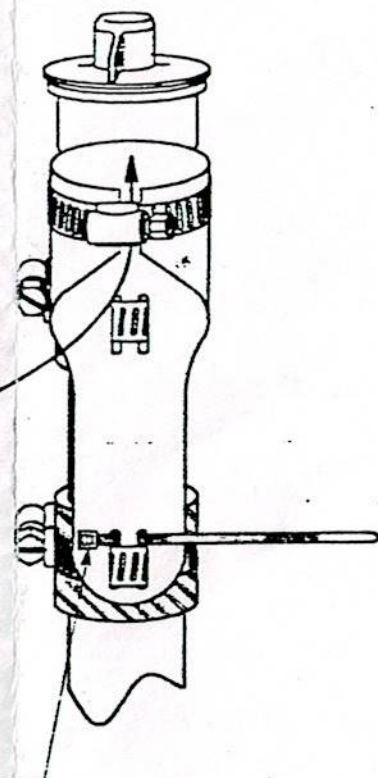
FIG. 5
HARNESS PLUG
INSTALLED IN PMT
SECURED WITH WORM
CLAMP AND TIEWRAP.
BE SURE PLUG IS
ACCESSIBLE THROUGH
OIL DOOR.
