AIRCRAFT
MAINTENANCE
RECORDKEEPING
SYSTEM

N611BJ

**AVIONICS
MAINTENANCE
RECORDS**

Aircraft Registration No. N611RJ
Aircraft Manufacturer The Lancoir Co.
Model LC4-550 FL
Serial No. 41044

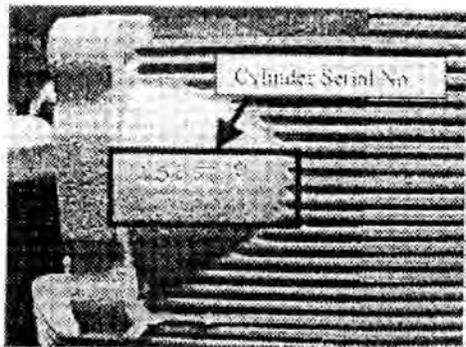
Figure 1. ↑

(i) Determine the SN of the cylinder by looking in the engine records or by inspecting the cylinder for a SN on the intake port boss (see Figure 1) or on the flat area next to the head to barrel junction (see Figure 2). Disregard any dash numbers that might follow the four digit SN.

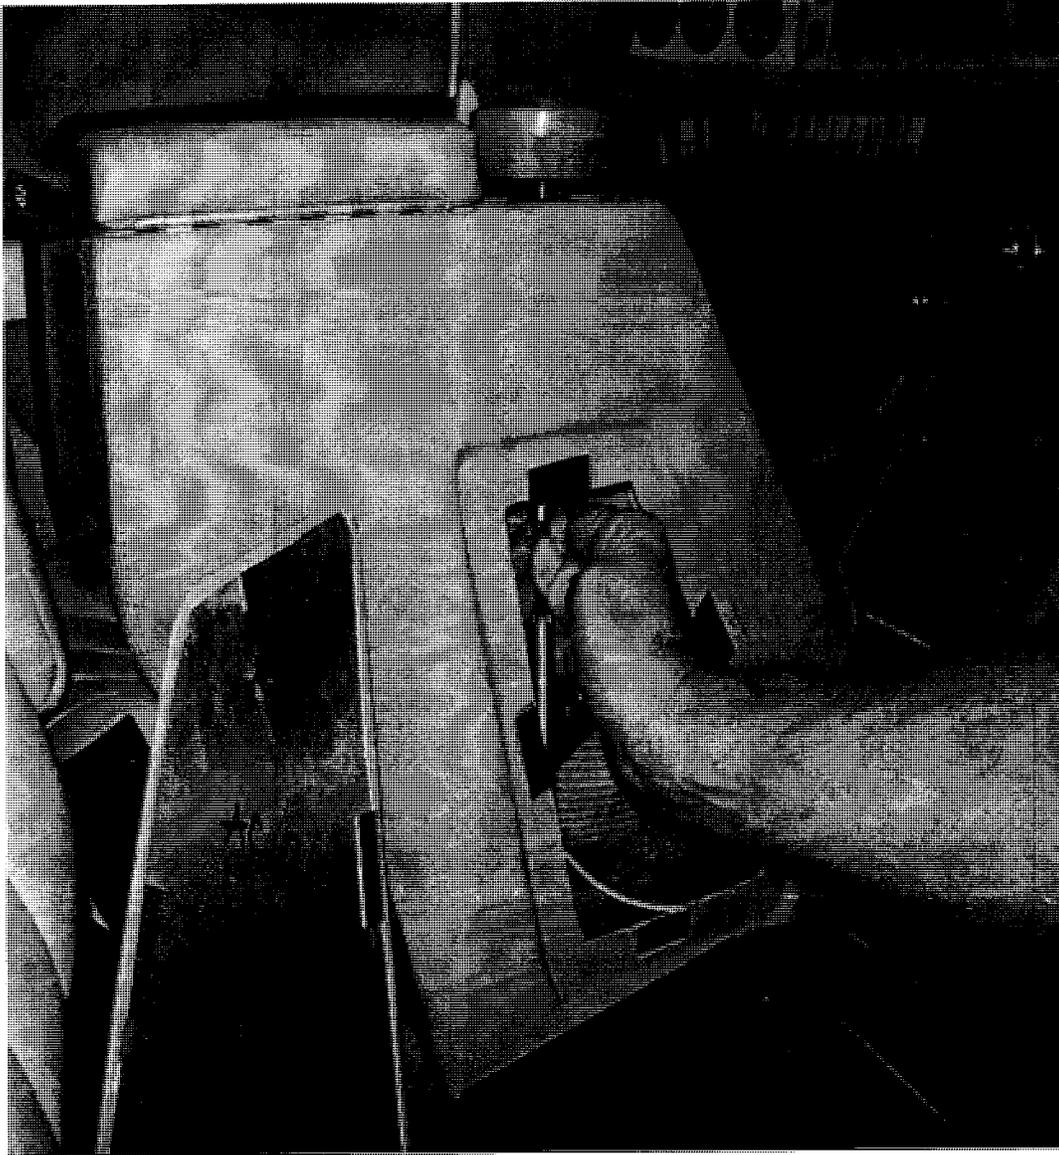
Figure 1
Pushing shaft up

2. Remove the co-pilot seat cushion and center console access panel per the Lancair 350/400 AMM Ch.25.
3. With one hand grab the fuel selector shaft through the access panel hole and push on the shaft. With the shaft pushed up rotate the fuel selector knob with the opposite hand checking for security of the knob assembly to the shaft. Reference **Figure 1** and **Figure 2**.

1. Remove the co-pilot seat cushion and center console access panel per the Lancair 350/400 AMM Ch.25.
2. Remove the fuel selector knob by inserting a Phillips screwdriver up through the inside of the center console through the access hole in the fuel selector plate and remove the three knob retaining screws, rotating the knob to gain access to each screw. Reference **Figure 3**.

3. Remove the fuel selector retaining plate Allen head attach screw. Reference **Figure 3**.
4. Apply Loctite® 242 thread lock adhesive to the threads of the fuel selector retaining plate screw and reinstall hand tightening snug.

5. If "OFF" engravings on the fuel selector plate are not red, apply red paint, supplied in Compliance Kit CK-003, to the "OFF" markings (2) and let dry. Reference **Figure 3**.

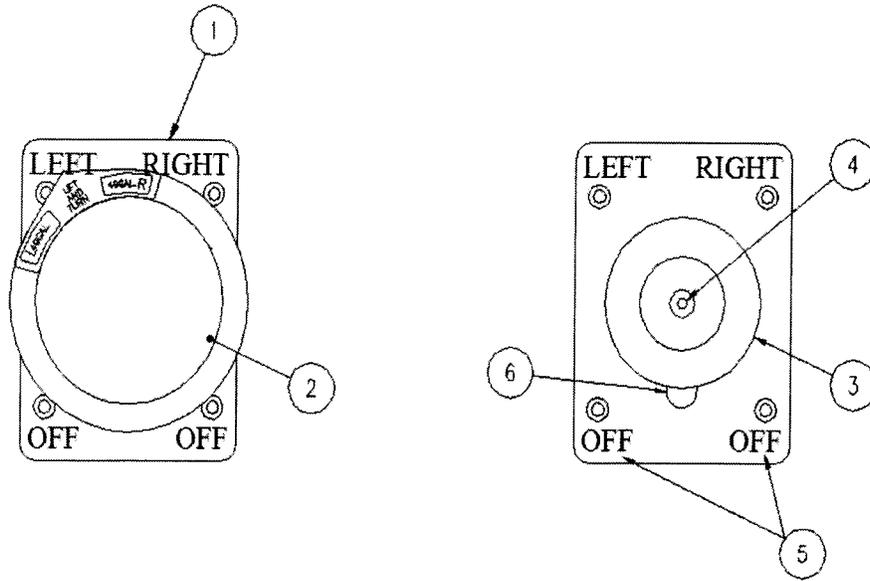
Figure 3

1. Fuel selector plate
2. Fuel selector knob
3. Fuel selector retaining plate
4. Fuel selector retaining plate attach screw
5. "OFF" markings, to be marked in red
6. Fuel selector plate access hole
7. Selector knob attach screws

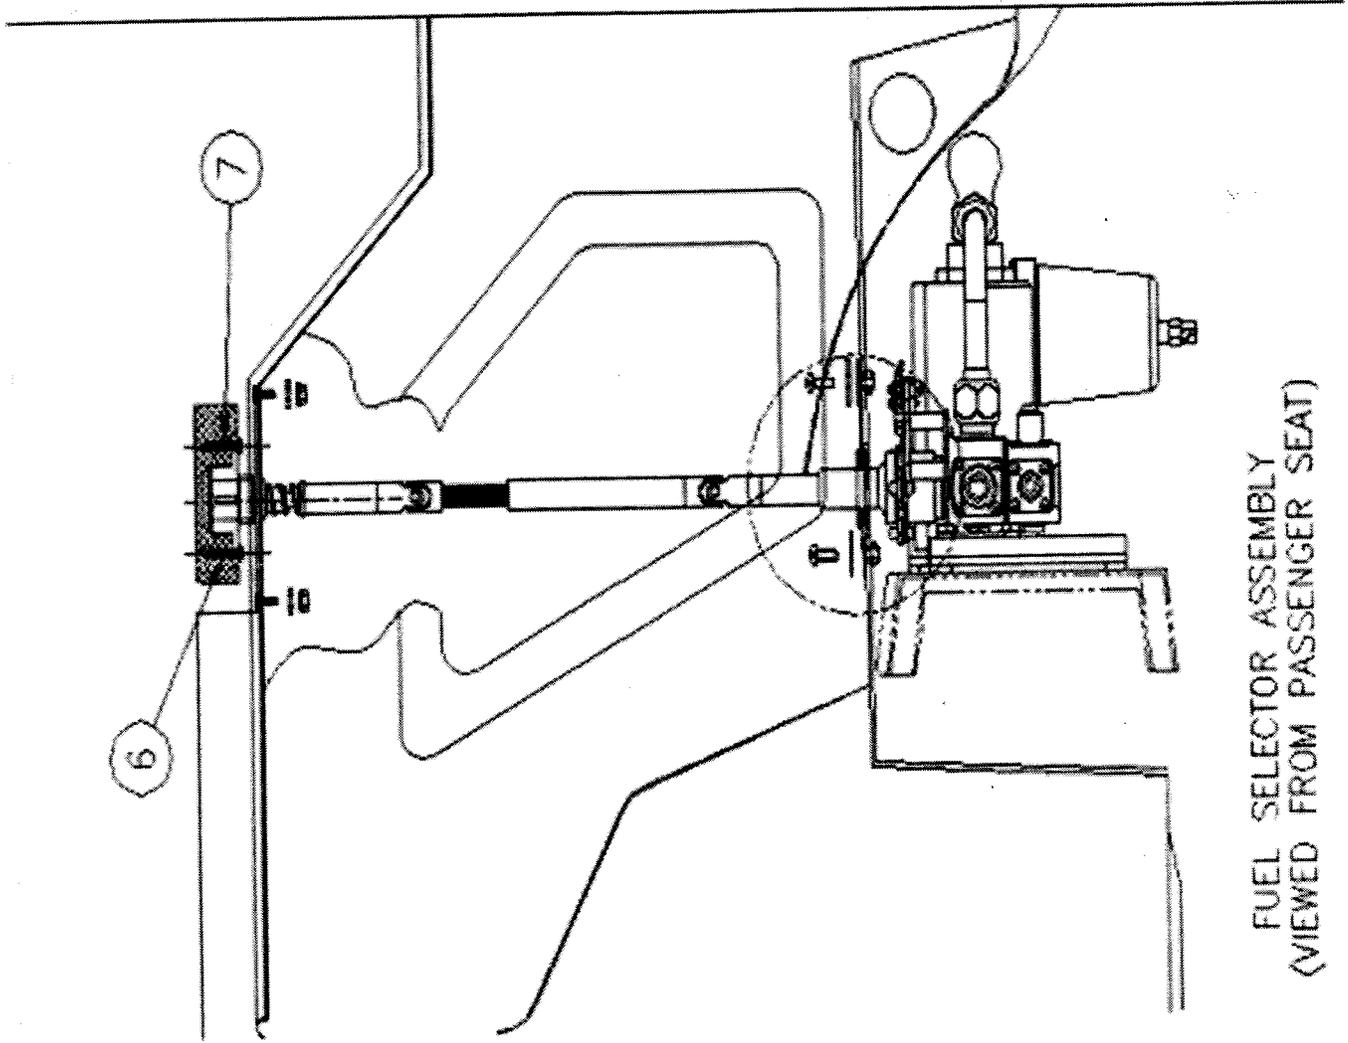
Figure 3

FUEL SELECTOR ASSEMBLY
(VIEWED FROM PASSENGER SEAT)
